Inspection Notice
MSA Latchways® Guided Type Fall Arrester
 February 2024
 PLEASE READ AND TAKE ACTION NOW

This Inspection notice is to inform you of a one-time inspection procedure regarding the locking pin on MSA Latchways® Guided Type Fall Arresters (GTFAs) that were manufactured between February 16, 2021 and January 30, 2024. Potentially affected models are listed in Table 1 below.

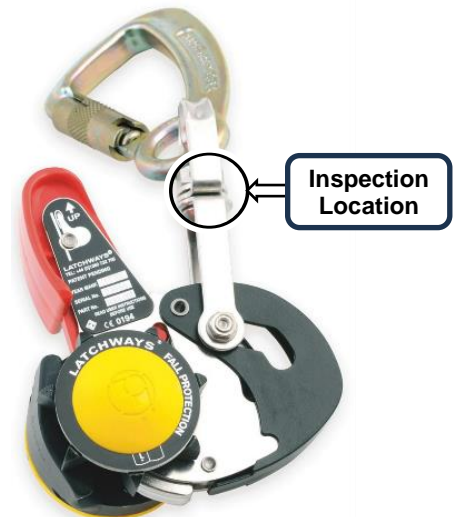
Figure 1: GTFa

MSA has received a field report of an MSA Latchways GTFa that did not have a locking pin in the nut of the swivel connector between the carabiner and main body of the unit. Without this locking pin in place, there is potential for the connection to come loose during operation.
