CUSTOMER ADVISORY NOTICE

Unused/Unopened Stockpiles of
3M™ Economy Battery TR-330
3M™ High Capacity Battery TR-332
3M™ Versaflo™ PAPR Unit TR-302N
3M™ Battery Charger Cradle TR-340

July 15, 2018

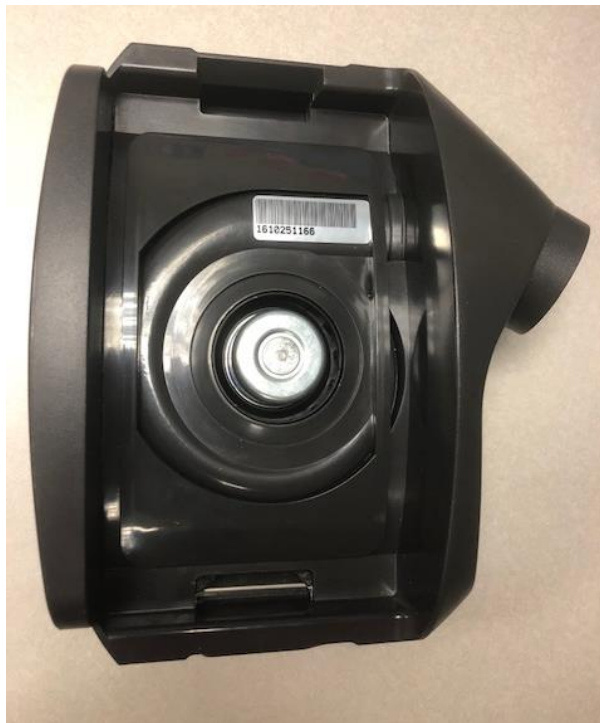
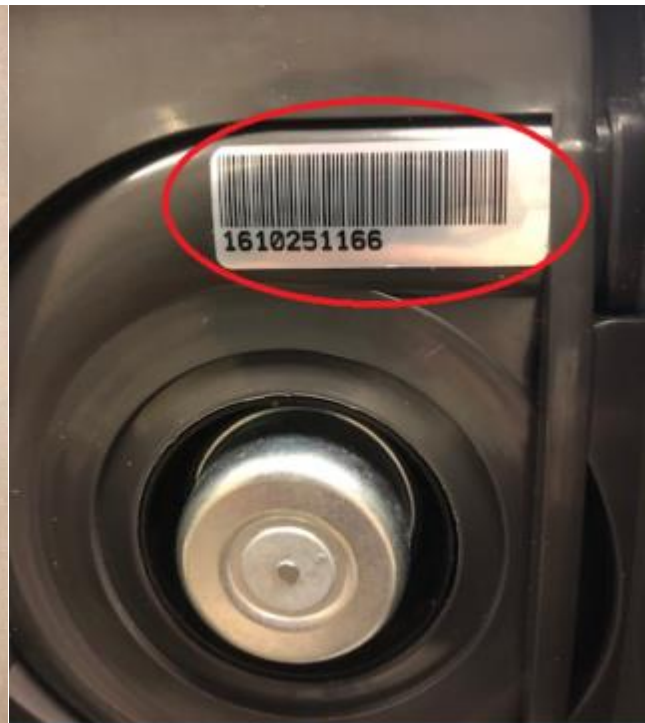
Fig. 1

3M has developed, since launch, new firmware for the motor blower to improve operation of the units. If you have stockpile of unused TR-302N motor/blower units still in the original box, 3M can replace certain unused/unopened units with new product free of charge. To determine if you are eligible for replacement product, please identify the serial number (Fig. 2) located on the motor/blower housing where the filter attaches. If you have any TR-302N motor/blower units that have serial numbers with the first 6 digits between 141114 and 150830 only, please call 800-355-6682 to find out more information about obtaining replacement product.

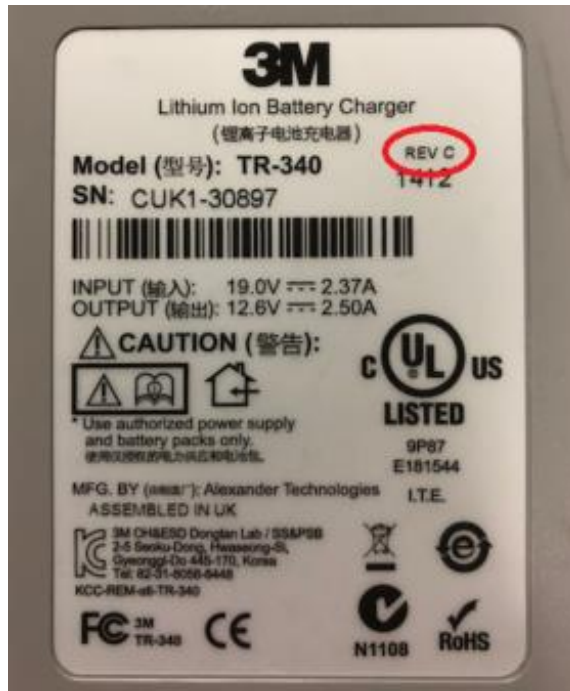
Fig. 2

In addition to the motor/blower, the TR-340 charging cradle has also undergone improvements to the device's firmware. Please check your unused/unopened stockpile of TR-300 kits that contain a TR-340 charging cradle, as you may be eligible for 3M to replace certain unused/unopened charging units with new product free of charge. To determine if you are eligible for replacement product, please remove the TR-340 charging cradle from the box and identify the Rev # on the underside of the charging cradles (Fig. 2). If your unused/unopened charging cradle is Rev A or Rev C only, please call 800-355-6682 to find out more information about obtaining replacement product. If your charging cradle has been put into use, you should continue to use the TR-340 charging cradle as normal.
